INDOOR AIR QUALITY ASSESSMENT

**Bernardston Town Hall
1 Main Street
Bernardston, Massachusetts**

Prepared by:
Massachusetts Department of Public Health
Bureau of Environmental Health Assessment
Emergency Response/Indoor Air Quality Program
October 2002

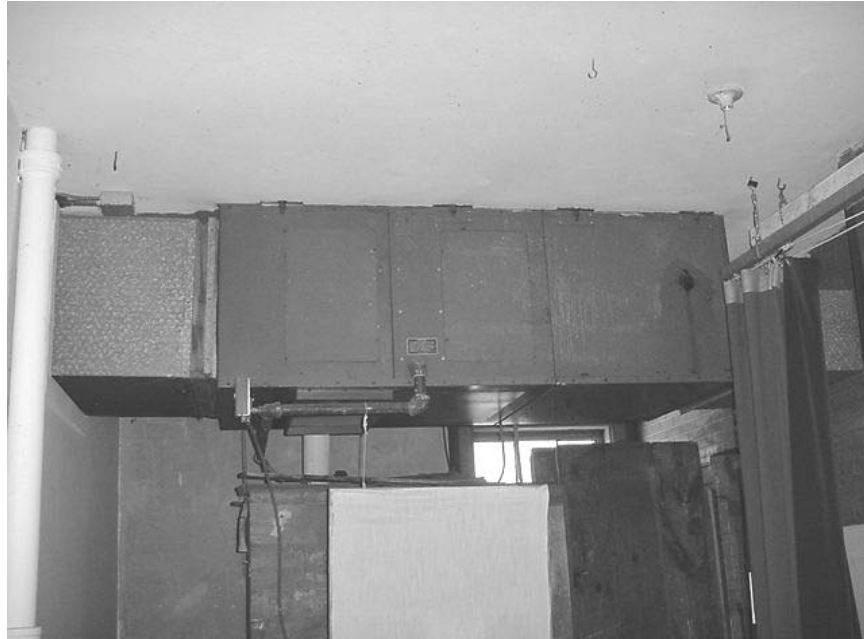
Picture 1

The second floor contains two air-handling units installed over the stage (see Picture 1). Town employees report that these units have not been used for a period of

AHUs over stage on 2nd floor

3. Examine each AHU for function. Repair AHUs if feasible and operate during business hours. Check fresh air intakes for repair and increase the percentage of fresh air intake if necessary.

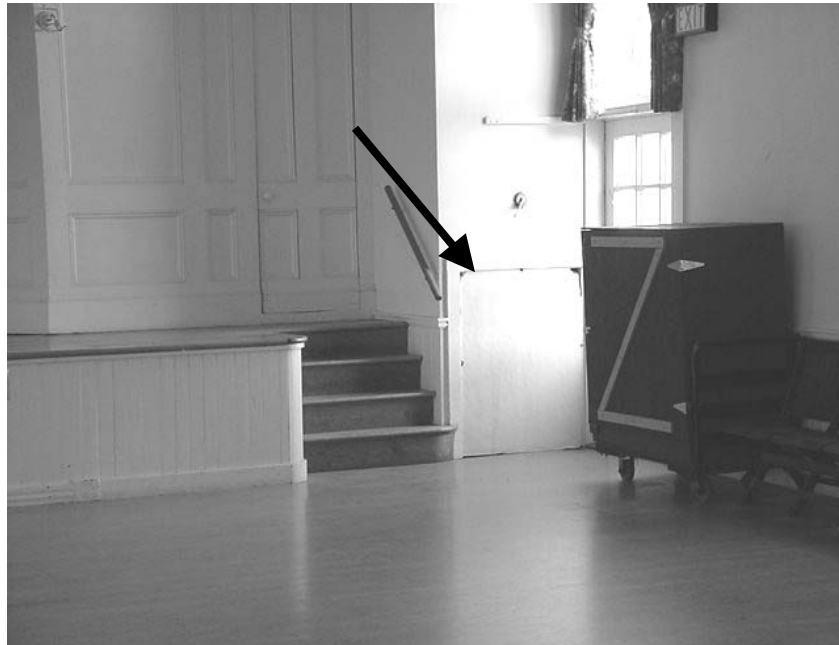
Picture 2

time. Two abandoned exhaust vents also exist in the building: one to the left of the stage on the second floor (see Picture 2) and the second located on the wall to the left of the kitchen (see Picture 3). Each vent was connected to a cupola on the roof (see Picture 4) via ductwork. Exhaust vents were sealed, possibly as an energy conservation measure. The sealing of these vents prevent their intended operation. At the time of the assessment, the sole operating mechanical exhaust ventilation systems that existed in the building were a stove vent in the kitchen (see Picture 5) and restroom exhaust vents (see Picture 6). With the kitchen and restroom exhaust vents deactivated, no operating mechanical exhaust ventilation exists in this building.

Abandoned Exhaust Vent in Auditorium

4. Examine the feasibility of restoring exhaust ventilation system. Operate exhaust vents during business hours. Please note that steps to remove bird waste from vents should be done prior to any work on this system. Once fresh air supply is increased, the ventilation system should be balanced by an HVAC engineering firm.

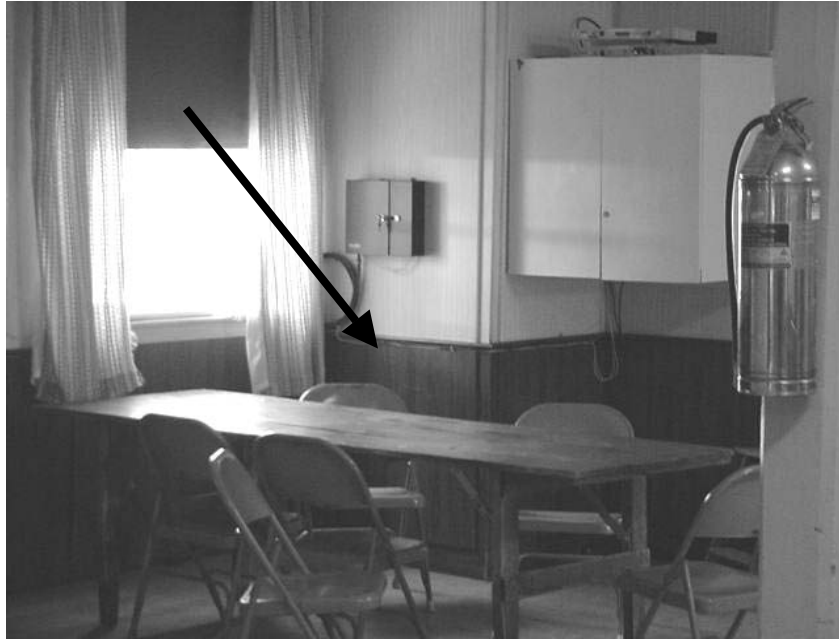
Picture 3

Location of Walled-over Vent on 1st floor

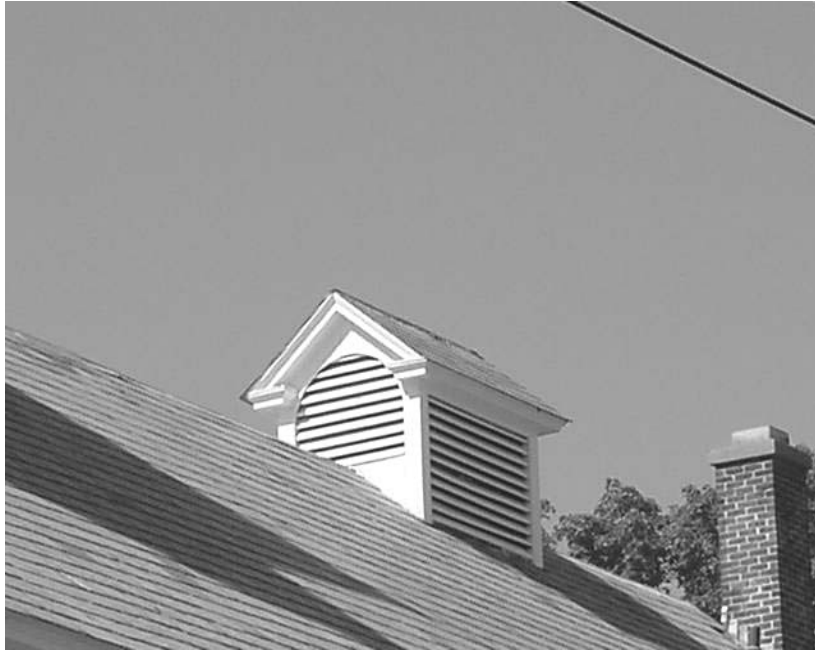
Picture 4

Cupola on Roof that is Exhaust Ventilation System Terminus

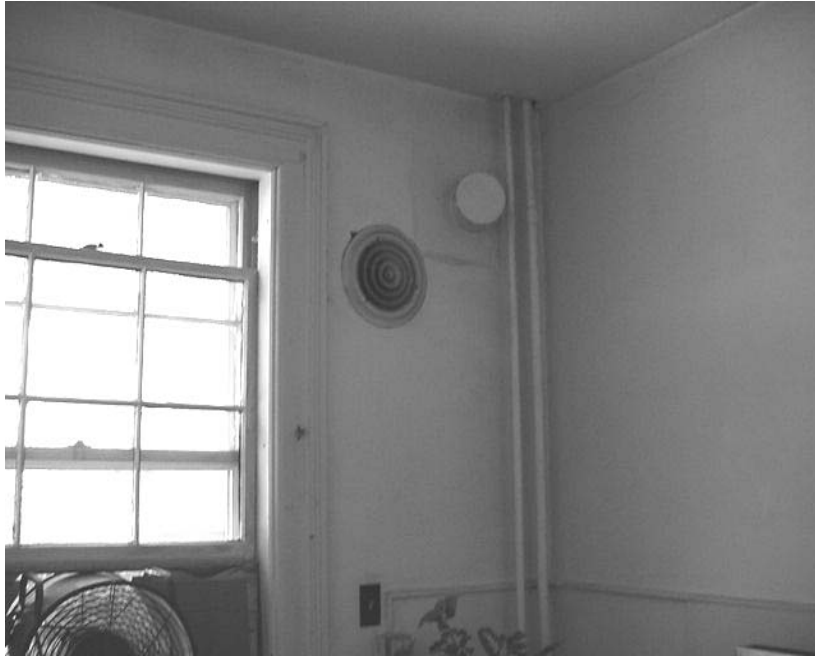
Picture 5

Exhaust vent in kitchen

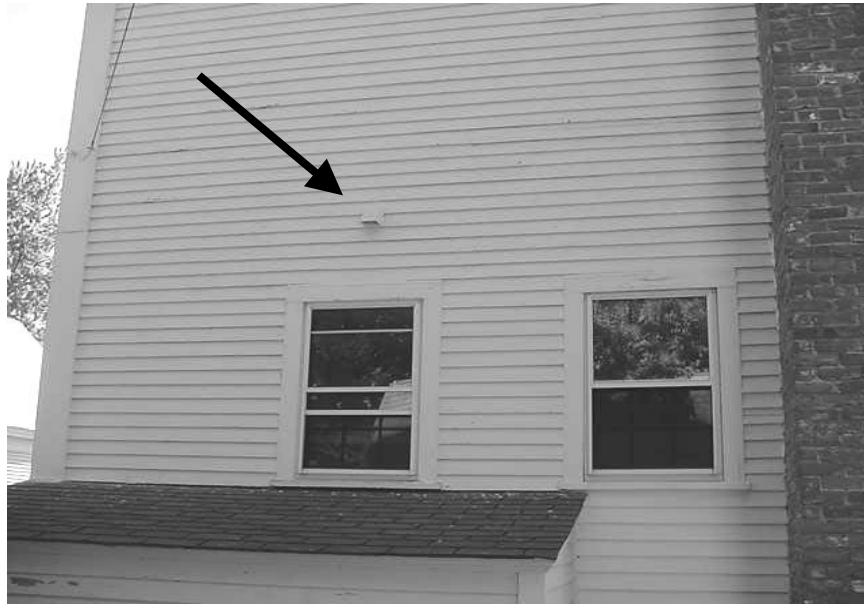
Picture 6

Restroom Exhaust Vent Terminus on Exterior Wall

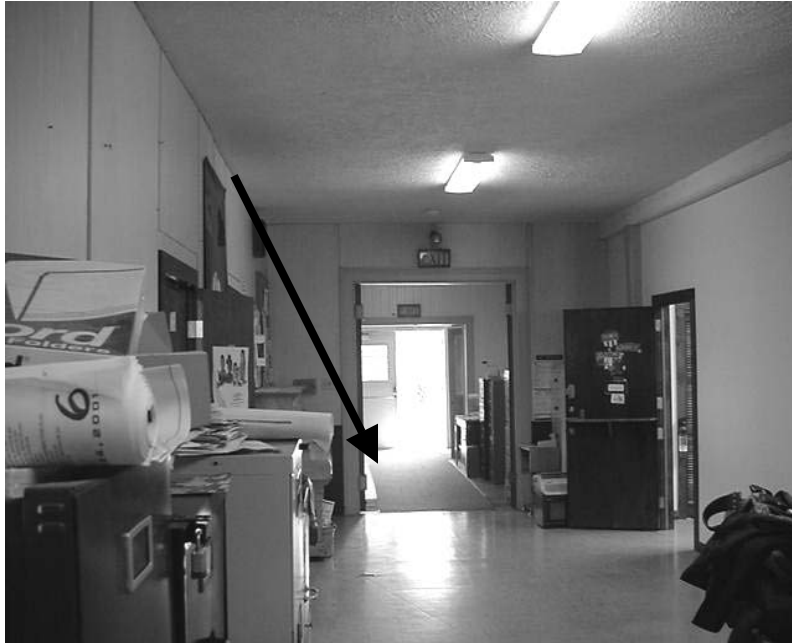
Picture 7

Building occupants reported noticeable chemical odors on September 17, 2002. A musty odor was detected upon entry of the building through the front door of the town hall during the September 24, 2002 visit. The odor was attributed to a carpet installed on

plywood (see Pictures 7 and 7A) in the front foyer. BEHA staff suggested to Bernardston town officials that the carpet be removed to eliminate the musty odor.

Plywood Foyer Floor Prior to Carpet Removal

- 1) Remove carpet from foyer (already accomplished).
- 2) Seal plywood sheet seams with duct tape (already accomplished) (see Picture 7A).

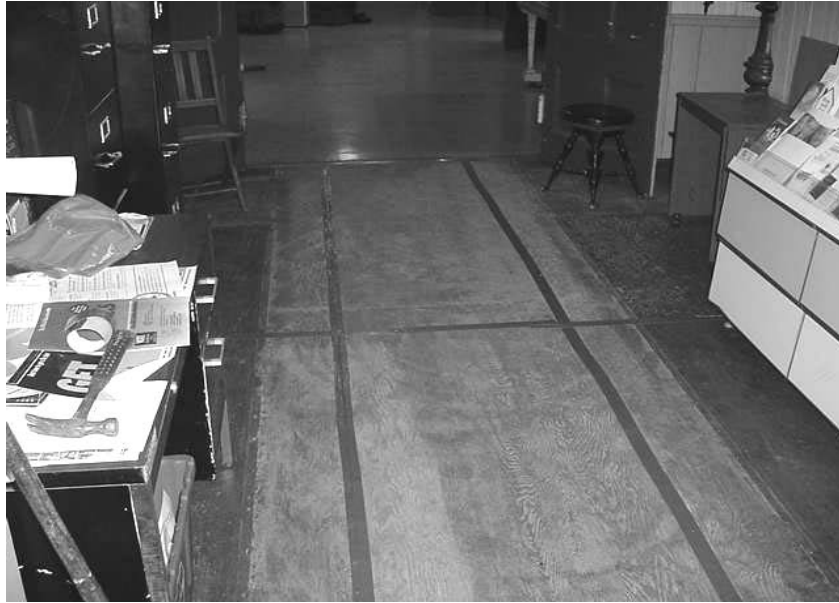
Picture 7A

Plywood Foyer Floor Subsequent to Carpet Removal

- 3) Remove the plywood flooring in the foyer. Replace with a material with continuous, sealed seams to prevent crawlspace air from penetrating into occupied areas.

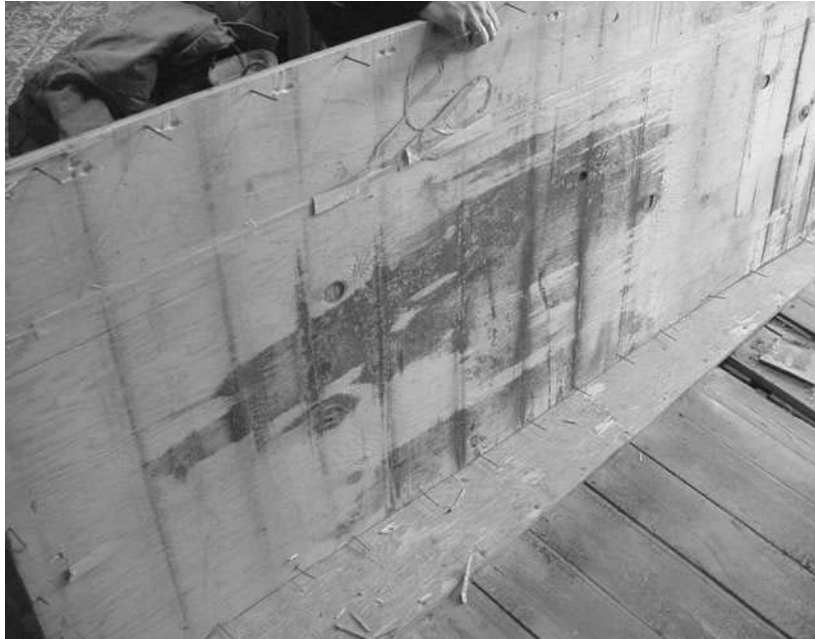
Picture 8

Plywood with Accumulated Dirt and/or Mold Colonization

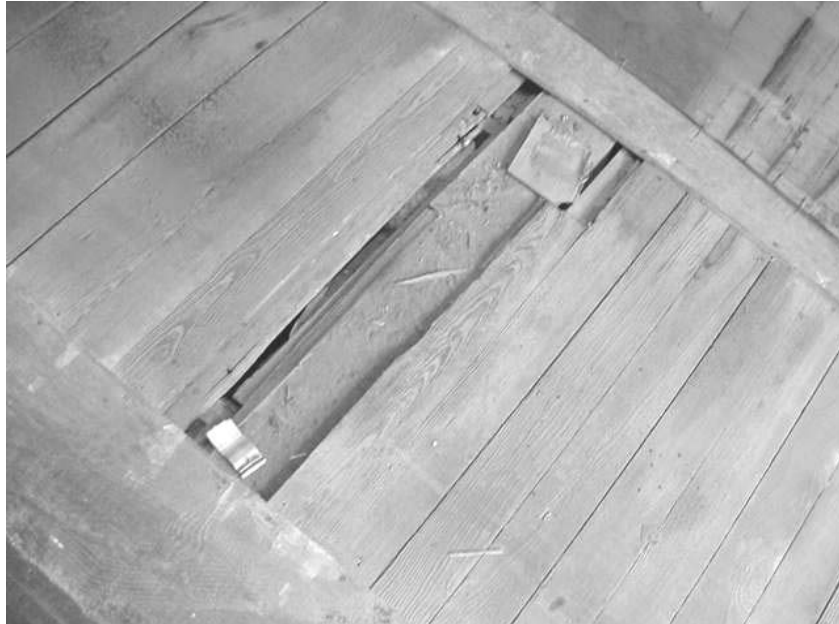
Picture 9

Hole in Original Floor Boards Open to Crawlspace, Covered with Plywood

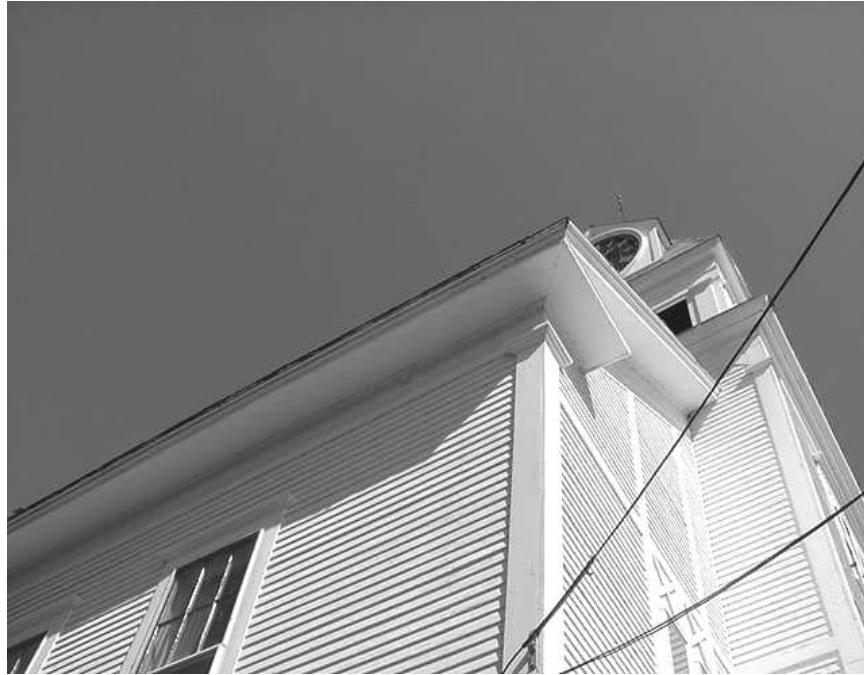
Picture 10

4. The building has a peaked roof without gutters and downspouts (see Picture 10).

Rainwater pools at the base of the building on the east exterior wall of the building and on tarmac that splashes onto the foundation (as indicated by moss growth on brick). The foundation consists of brick installed over piled flagstone (see Picture 11). The composition of the foundation can make it prone to water penetration.

Pitched Roof Edge without Gutter/Downspout System

- 5) To prevent moisture penetration into the crawlspace, the following actions should be considered:
 - a) Install gutters and downspouts to direct rainwater at least five feet away from the foundation.

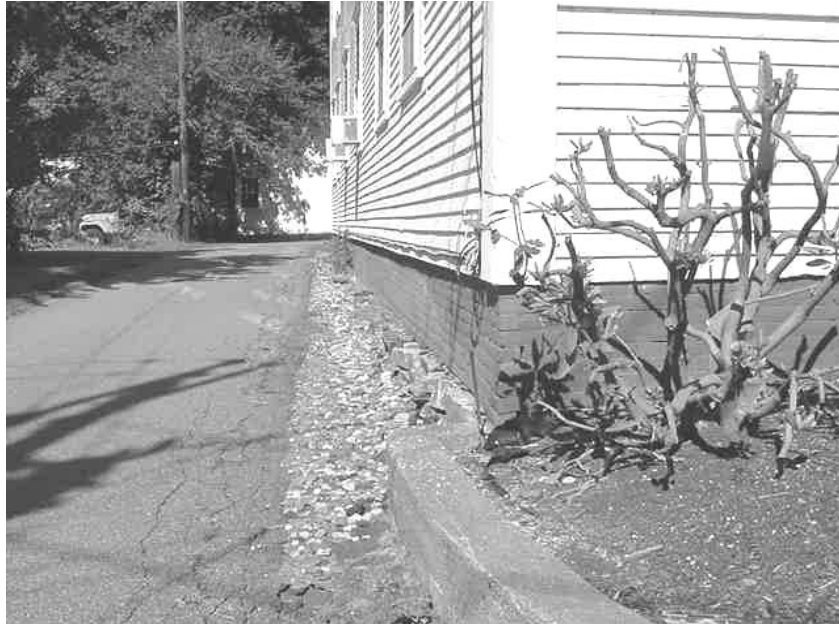
Picture 11

Brick/Flagstone Foundation of Town Hall

Control of water penetration through the foundation can be limited by installing gutters and permanently rendering watertight former window frames in the basement.

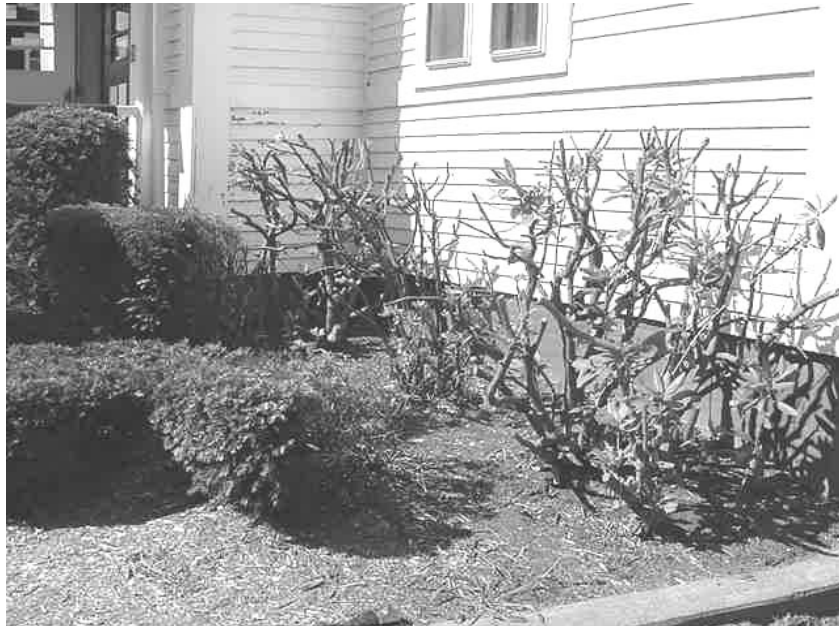
Picture 12

Shrubbery in Close Proximity to Foundation

- b) Remove foliage to no less than five feet from the foundation.
 - c) Improve the grading of the ground away from the foundation at a rate of 6 inches per every 10 feet (Lstiburek, J. & Brennan, T.; 2001).

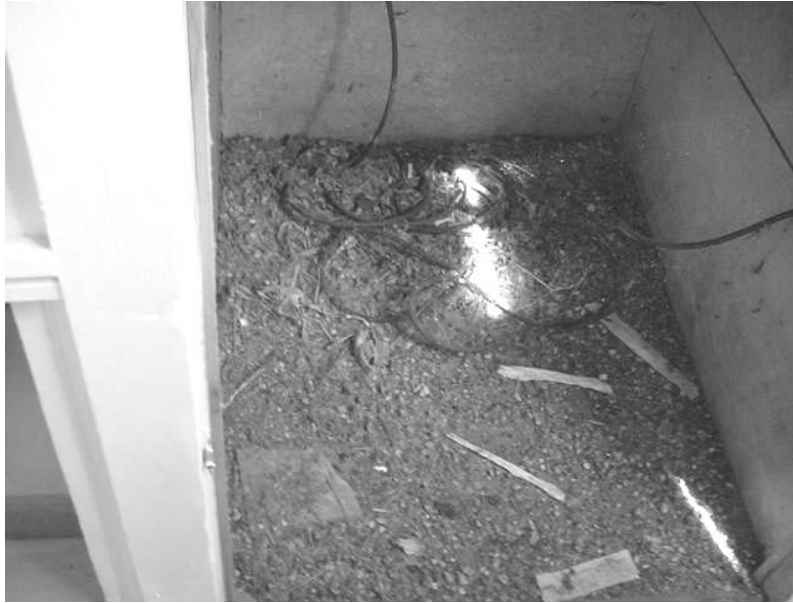
Picture 13

Of note was the accumulation of bird skeletons and wastes observed inside an abandoned exhaust vent in the auditorium and attic (see Pictures 13 and 14). Town officials reported a heavy bird infestation inside the attic of the building. Bird wastes in a building raise concerns over diseases that may be caused by exposure to bird wastes. These conditions warrant clean up of bird waste and appropriate disinfection. Certain molds are associated with bird waste and are of concern for immune compromised individuals. Diseases of the respiratory tract may also result from exposure to bird waste. Exposure to bird wastes is thought to be associated with the development of hypersensitivity pneumonitis in some individuals. Psittacosis (bird fancier's disease) is another condition closely associated with exposure to bird wastes in bird raising and other occupational settings. While immune compromised individuals have an increased risk of health impacts following exposure to the materials in bird wastes, these impacts may also occur in healthy individuals exposed to these materials.

Floor of Auditorium Exhaust Vent

- 6) Discard carpets shown in Picture 15.
- 7) Operate the kitchen exhaust vent during business hours, regardless of cooking activities.
- 8) Have bird waste cleaned from attic and exhaust vents.

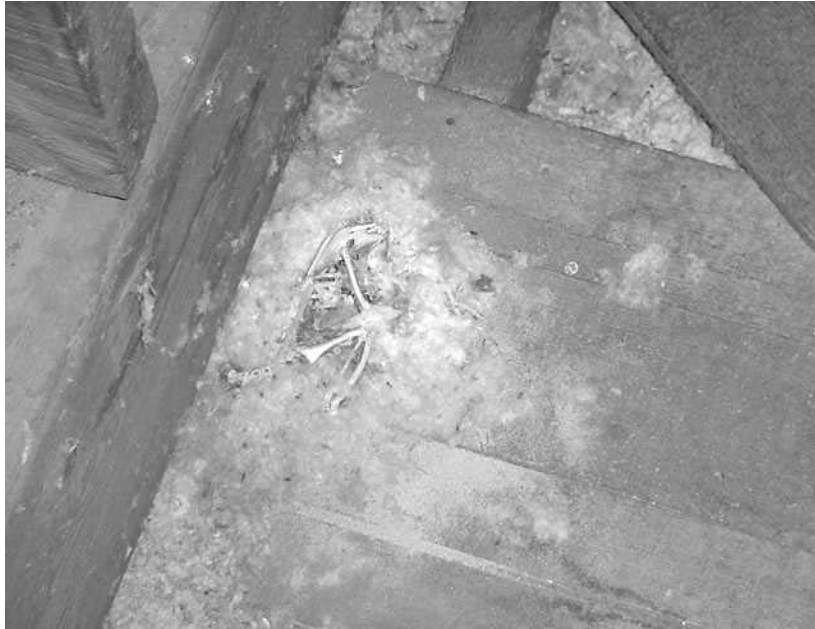
Picture 14

Bird Skeleton in Attic

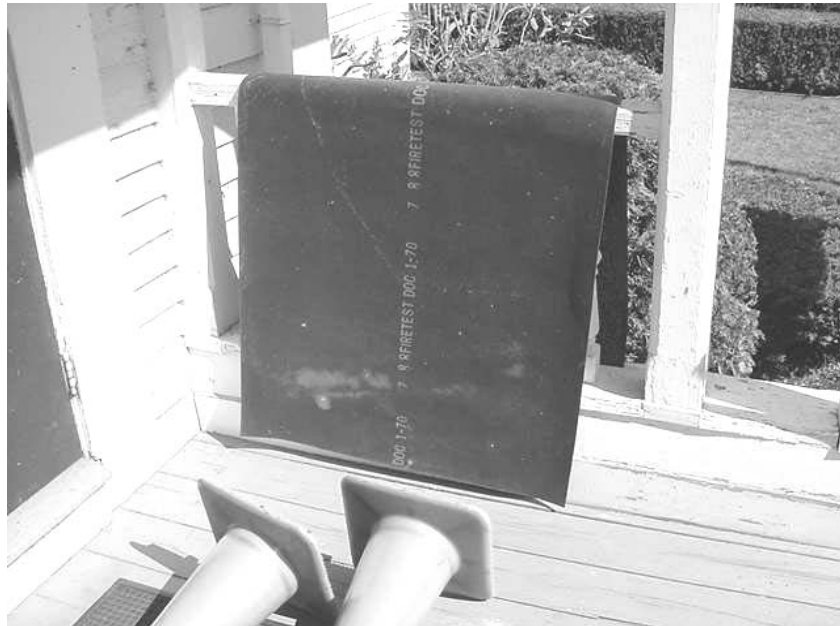
Picture 15

Non-fixed Carpets Removed from 1st Floor Hallway
